**FIRST FIVE-YEAR REVIEW REPORT FOR
CHEVRON QUESTA MINE SUPERFUND SITE
TAOS COUNTY, NEW MEXICO**

June 2017

**U.S. Environmental Protection Agency
Region 6
Dallas, Texas**

**FIRST FIVE-YEAR REVIEW REPORT FOR
CHEVRON QUESTA MINE SUPERFUND SITE
EPA ID#: NMD002899094
TAOS COUNTY, NEW MEXICO**

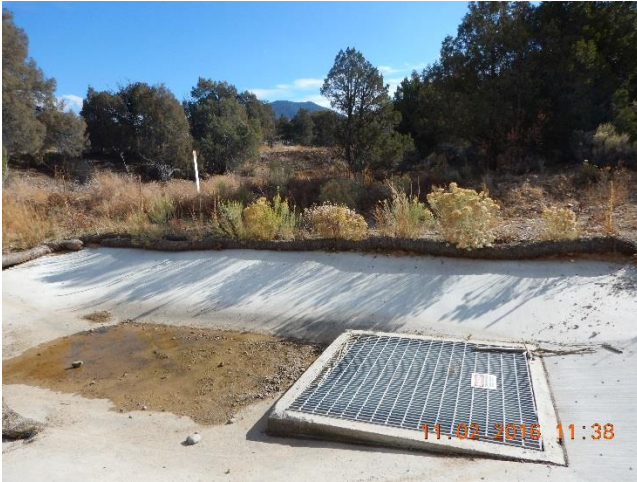
Eastern Diversion Channel – Inlet 1 11/2/16

Site inspection participants assessed the Lower Capulin Canyon Flume and moved to the Easter Diversion Channel area. Pipeline inlets were inspected and found clear of debris and functional. Water was observed to be emanating from the Eastern Diversion Channel pipeline outlet at Reach 5 during the Site inspection. This is likely the same perched ground water that was intruding into the pipeline during construction in June 2014. During installation of a drop structure at the upstream end of the Eastern Diversion Channel Reach 5 pipeline, shallow, perched groundwater was observed in the excavations.

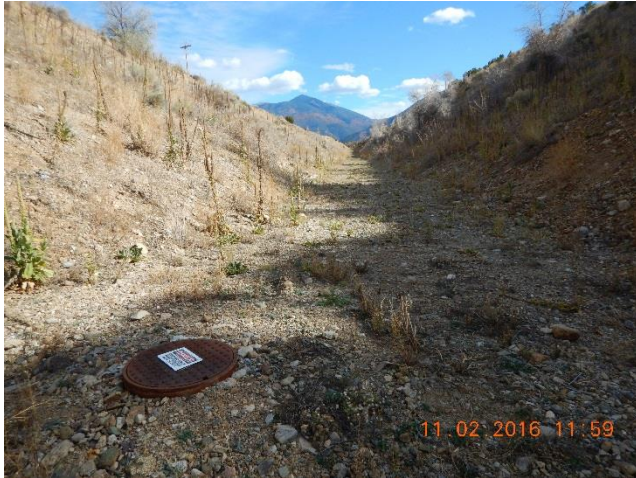
Eastern Diversion Channel – Manhole 1 11/2/16

The biannual inspections at the pipeline installed in the Eastern Diversion Channel identified small stress cracks in the concrete manholes and debris in the pipeline culvert that was removed by CMI. The stress cracks are considered a normal level of wear and do not affect the operation of the pipeline to manage irrigation waters.

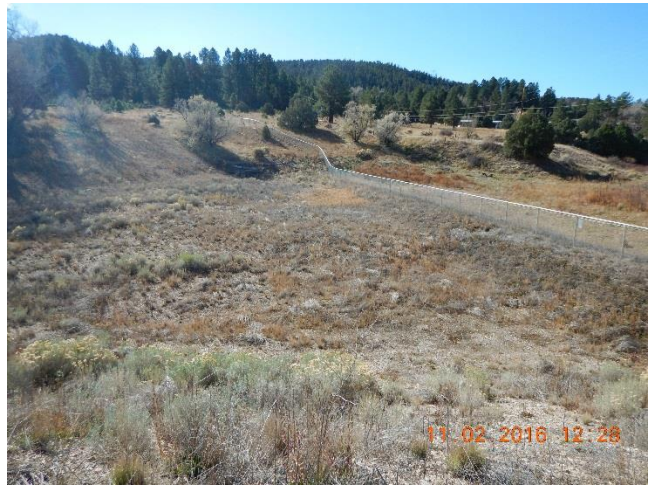
Lower Dump Sump area tailing removal 11/2/16

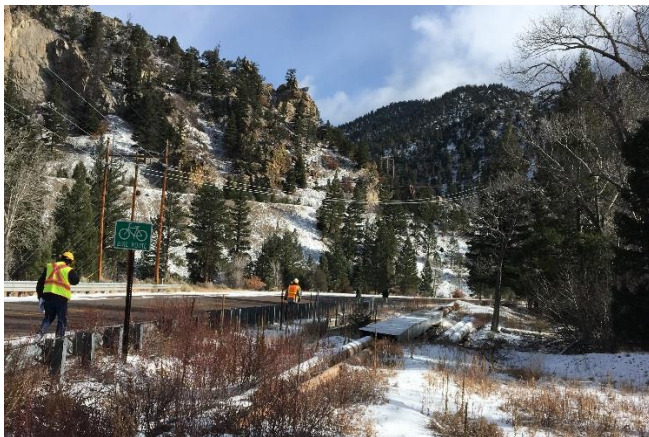
SH 38 – Walking tailing spill removal area 11/29/16

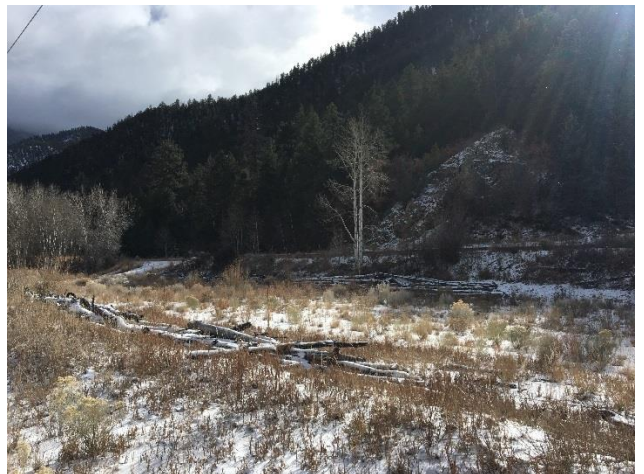
Area excavated to remove tailings 11/29/16

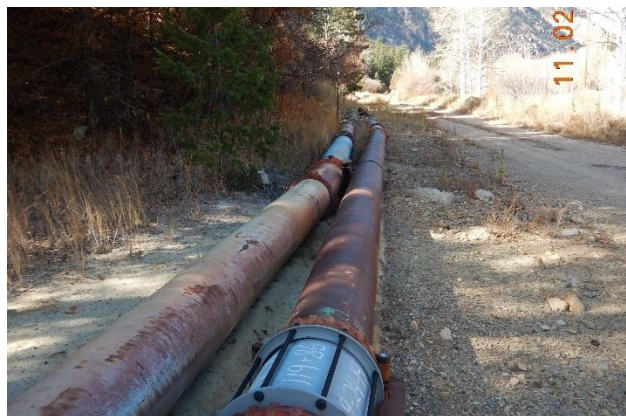
Tailing pipeline with tailing spills 11/2/16

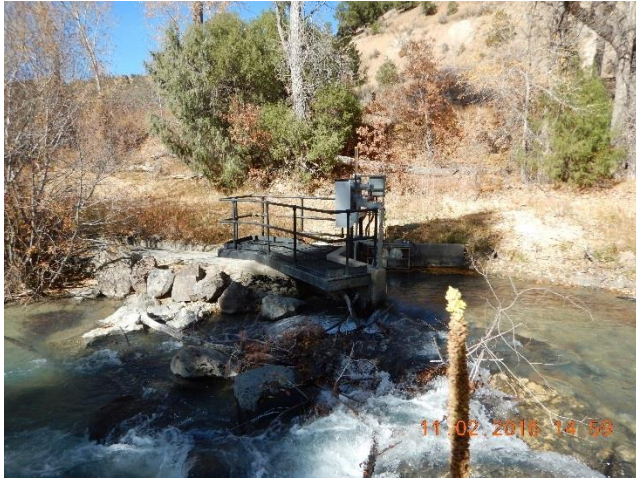
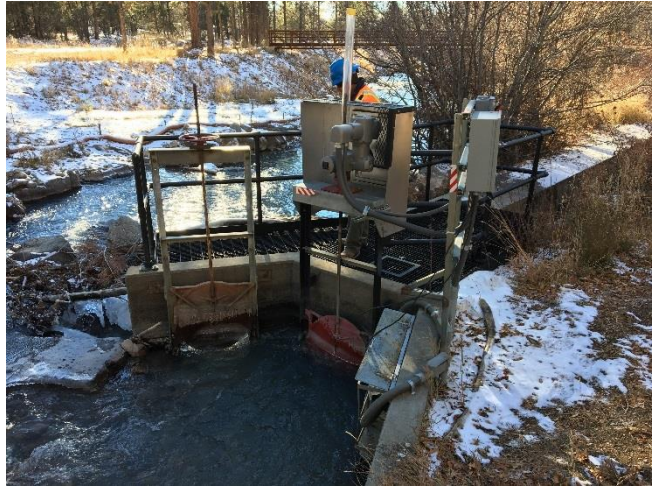
Eagle Rock Lake – head gate 11/2/16

CMI has indicated that the head gate at Eagle Rock Lake is functioning as intended, but the head gate failed to close completely due to woody debris under the head gate. Follow-up inspections confirmed that in both incidences the head gate was mostly closed with only a small amount of water entering the channel and the lake. Debris was removed promptly. After turbidity and conductivity levels attenuated below the high alarm, the head gate was reopened. CMI will install a grate to catch woody debris within the channel from the Red River and upstream of the head gate by July 2017.

- The Eagle Rock Lake head gate failed to close completely due to woody debris under the head gate. CMI will install a grate to catch woody debris within the channel from the Red River and upstream of the head gate by July 2017.
